The Locomotive

THE HARTFORD STEAM BOILER INSPECTION AND INSURANCE CO.

VOL. XXIX.

HARTFORD, CONN.
1912-1913.

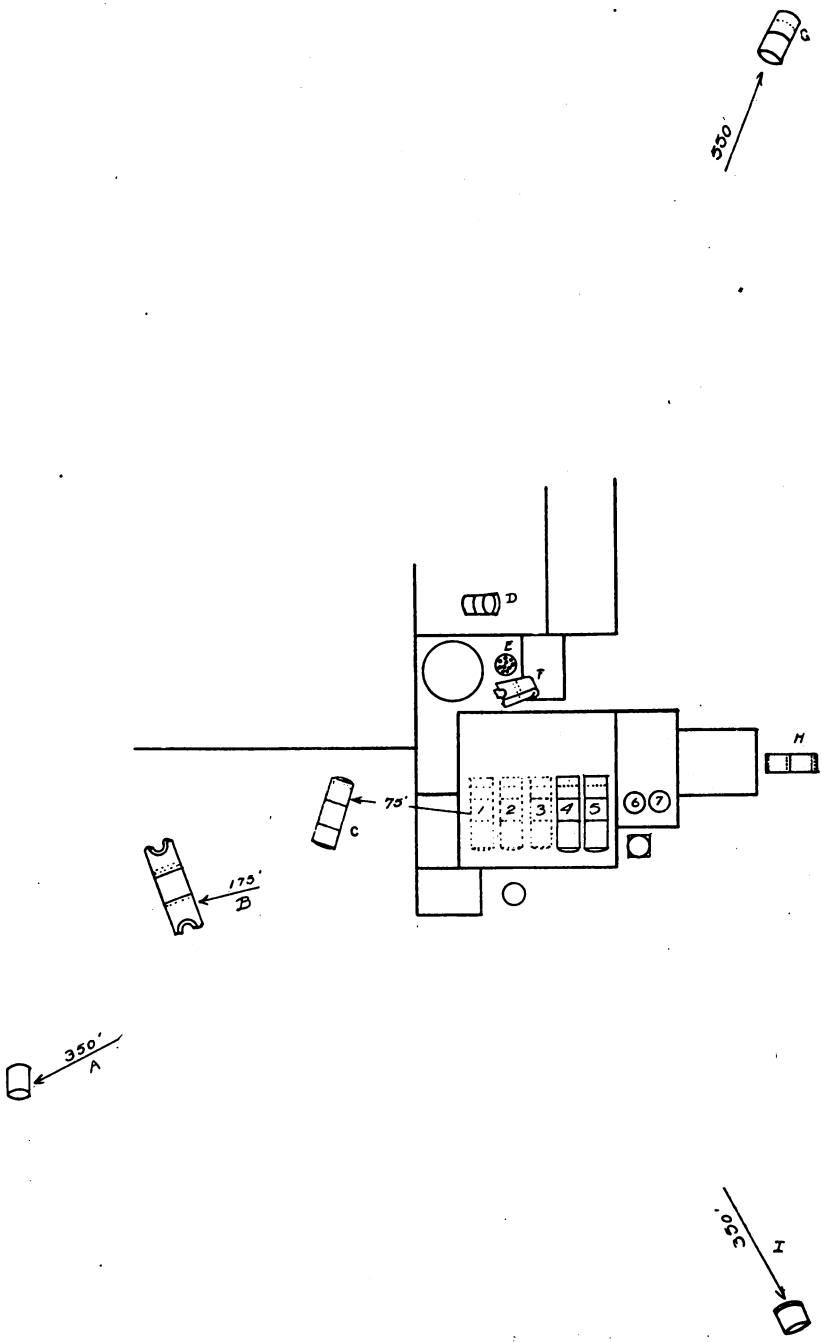
FIG. 1. PATHS OF PROJECTED BOILER COURSES.

There is some doubt as to which of the boilers first gave way. Witnesses testified to a double report like two pistol shots in rapid succession. It is probable, from the appearance of the failures, that one of the boilers exploded first, and struck its neighbor a blow of sufficient violence to set it off. Both the exploded boilers were of lap seam construction, built in five courses with outside cast iron man-hole frames attached to the third course. Both of them failed through the man-hole frame, and each man-hole course was ripped longitudinally from girth seam to girth seam, through the center line of the man-hole open-

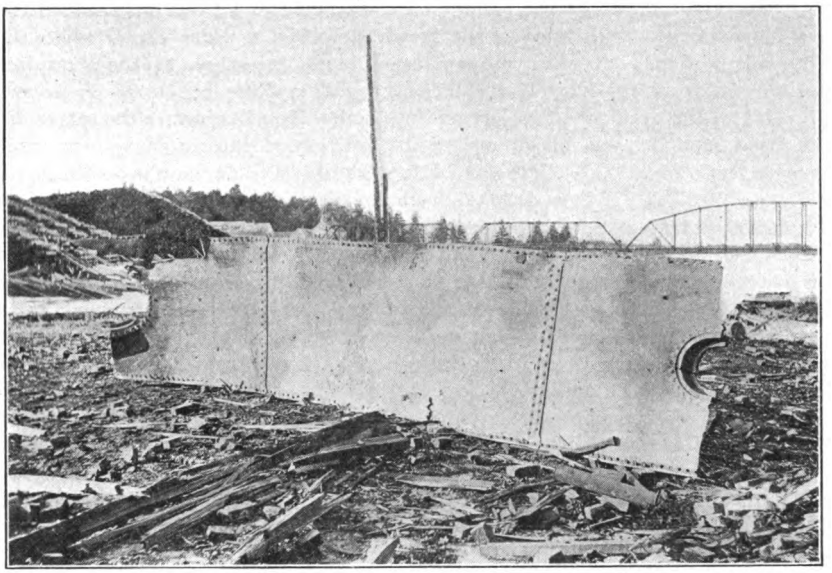
FIG. 3. RUPTURED MANHOLE COURSE "B."

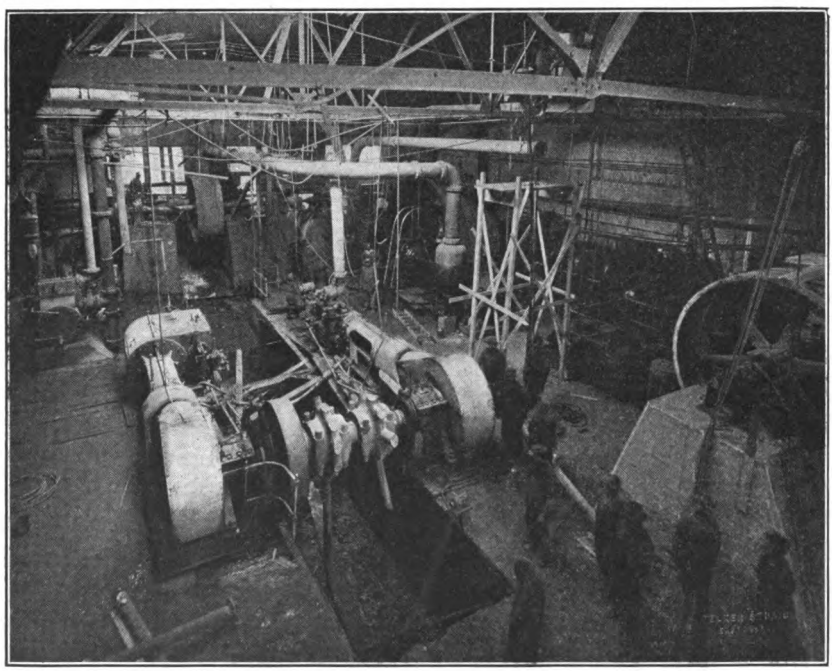
FLY-WHEEL WRECK, ALPHA, N. J.

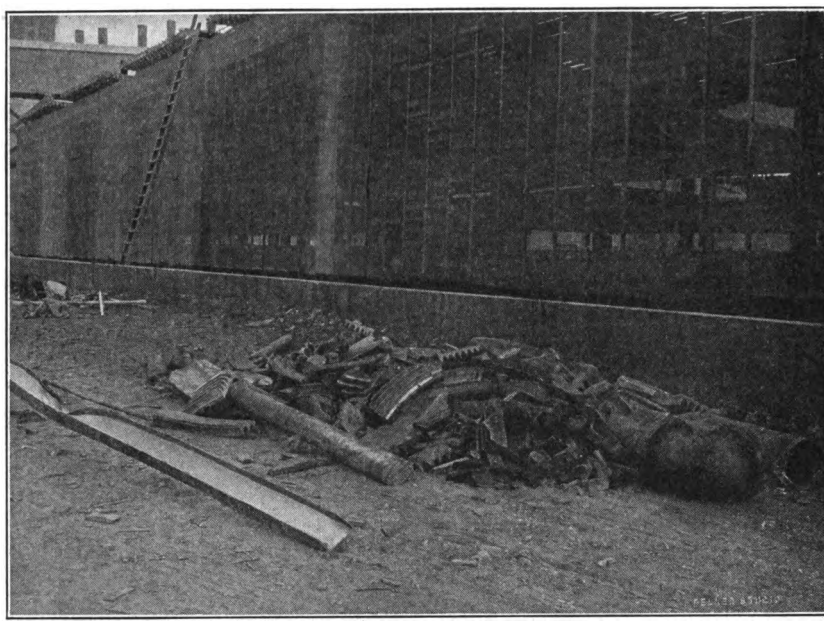
THE REMAINS OF THE FLY-WHEEL, ALPHA, N. J.

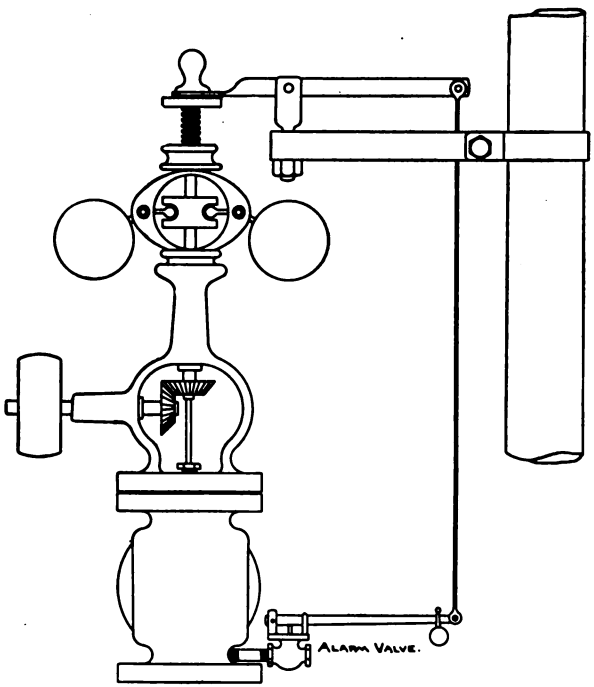
Sketch of the Alarm Valve and Governor.

A type of throttle valve governor is in use which while not equipped with an automatic safety stop in the strict sense of the word will nevertheless stop the engine if the belt breaks or runs off provided the engineer has not forgotten to set it in the "safe" position after starting his engine. With governors of this type before the engine can be started it is necessary for the engineer to screw down the small knurled nut which is at the extreme top of the governor. This operation lifts the throttle valve from its seat and holds it in this position, admitting steam to the engine. When the engine has attained its normal speed the nut should be screwed back again. The governor is then at "safety" and will operate to stop the engine if the belt breaks or runs off. Should the engineer forget this and the governor belt break while the nut is screwed down the engine would run away, which would probably result in a wrecked fly-wheel, with consequent damage to the building and its contents.

When inspecting engines equipped with governors of this type a small safety or alarm valve has been recommended to be attached to the throttle valve chamber at a point below the valve seat. From the lever of the alarm valve a connection is made to a second lever which is provided with a forked end to hook under the knurled nut on the governor as is shown in the accompanying sketch.

This little device has given satisfaction wherever it has been installed as directed. It prevents the engineer from forgetting to set the governor in its safe position while his engine is running, for when he screws down the nut on top of the governor it opens the alarm valve from which steam continues to flow until the nut is set back again to the safe position.

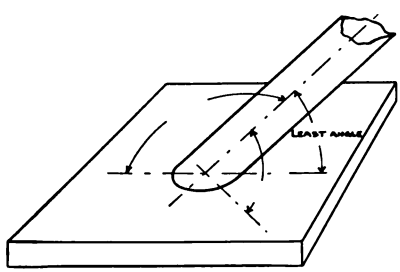
FIG. 2. ILLUSTRATING THE LEAST ANGLE BETWEEN THE BOLT AND THE SHEET.

The tables are nearly self explanatory, but perhaps a word is required to make clear what we had in mind as the "least angle." It is clear that if a stay bolt pierces a plate at any angle other than 90°, there is one least angle between it and the plate, while on the opposite side of the bolt from this least angle is a greatest angle. At any intermediate point the angularity of the bolt to the plate is somewhere between these limits, as is shown in Fig. 2. In every case the least angle has been used in making up the tables. In finished work, if it were accessible, this least angle would be the smallest angle that could be taken off with a carpenter's "bevel" held so as to touch both the bolt and the sheet fairly.

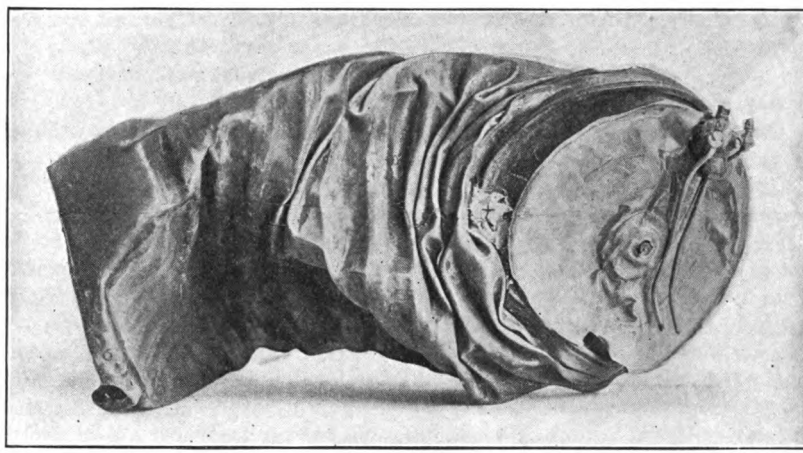
AN EXPLODED PEANUT ROASTING BOILER.

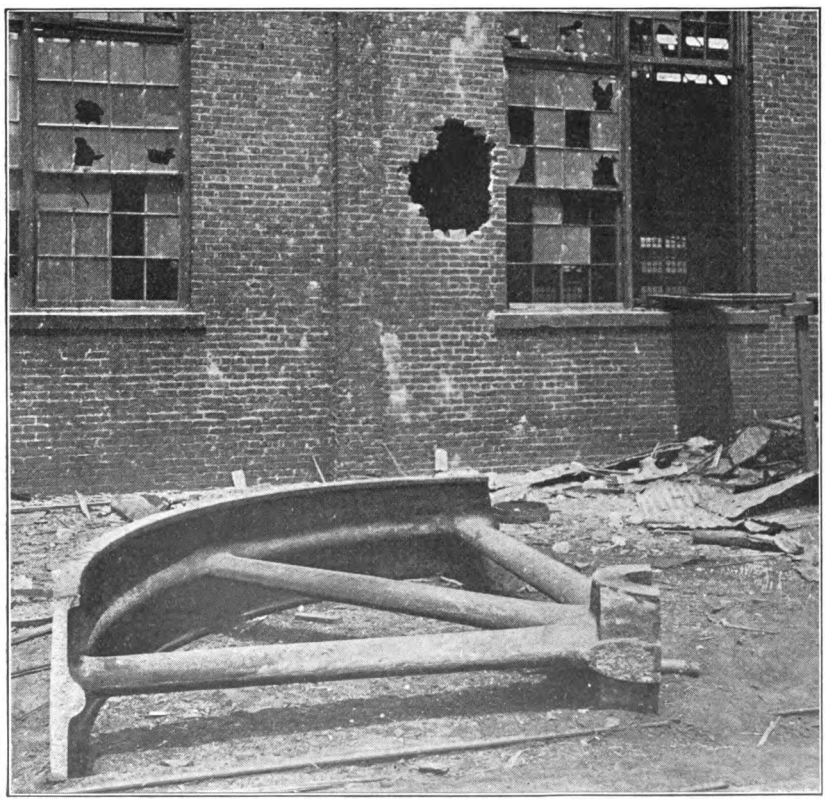
AN UNUSUAL FLY-WHEEL BREAK. BIRMINGHAM, ALABAMA.

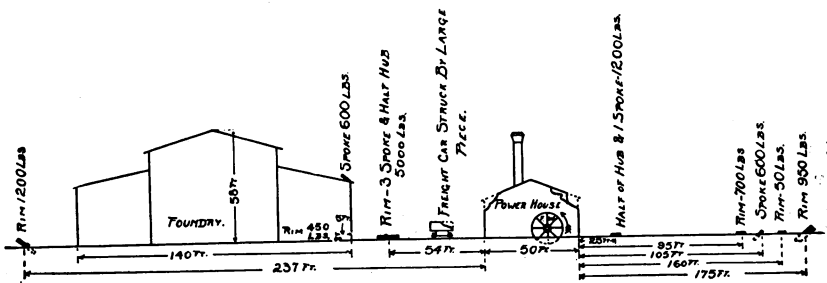
FIG. 1. SHOWING THE COURSE OF THE FRAGMENTS.

We are told that a considerable peak load on the generator caused the circuit breaker to operate, relieving the engine very suddenly. The subsequent racing was noticed by the fireman and he called to the engineer who had stepped out of the engine room. The engineer, realizing what had happened, ran for the throttle, but only succeeded in getting in the path of one of the larger fragments of the wheel. He was instantly killed.

Portions of the wheel were thrown both in front and to the rear of the engine, as is shown in detail in our sketch, Fig. 1. The roof and walls of the engine room were badly wrecked, though the roof had been repaired when the photograph Fig. 2 was taken. One large piece passed completely through a gondola car that was standing on a siding alongside the engine room, as our sketch shows.

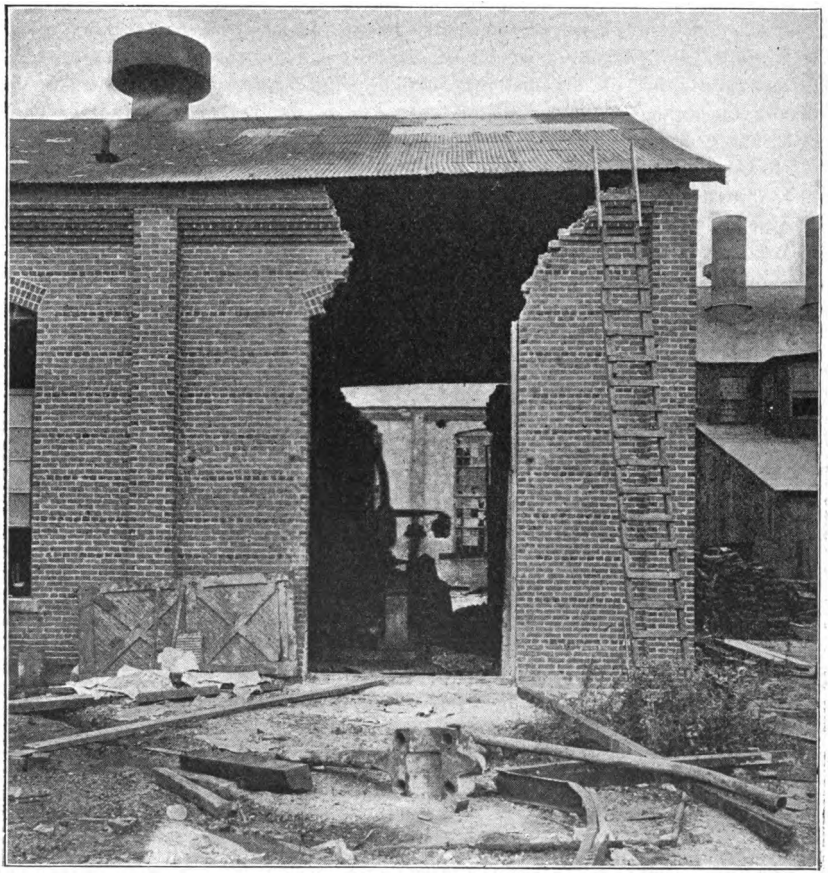
FIG. 2. THE WRECKED ENGINE ROOM.

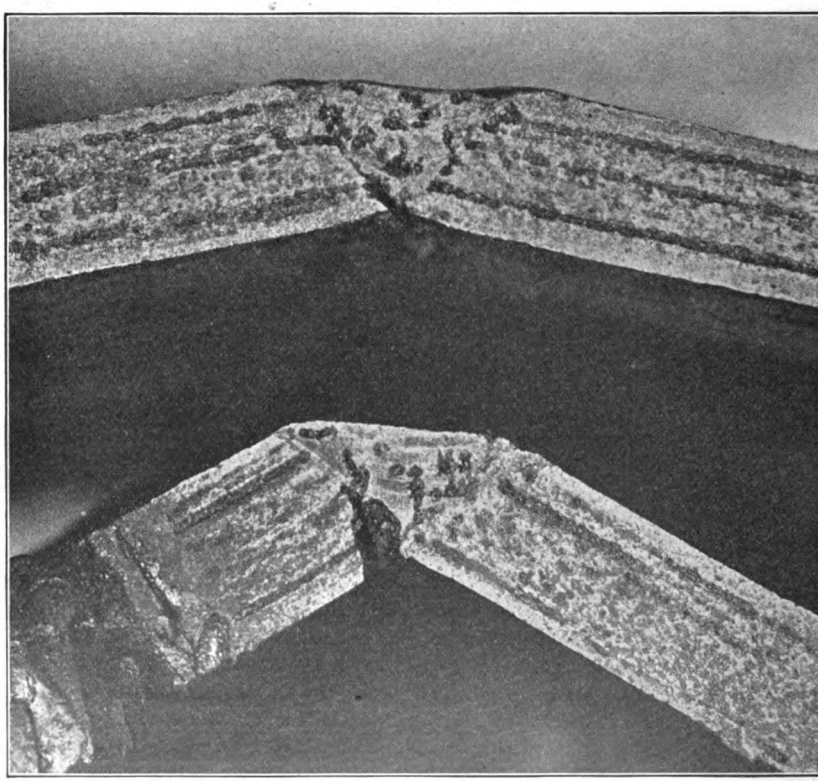
FIG. 1. (Upper.) ETCHED SECTION OF LONGITUDINAL SEAM.
FIG 2. (Lower). ETCHED SECTION OF WELD BETWEEN HEAD AND SHELL.

Professor Theodore Kautny of Nürnberg, who is considered one of the leading authorities of the world on this subject, is using his influence to prevent the autogenous welding of boiler shells until some reliable method can be devised for ascertaining the probable strength of a weld without destroying it. We also understand that the United States Government does not approve of acetylene welding for boiler repairs where the parts welded are subjected to tensile strain.

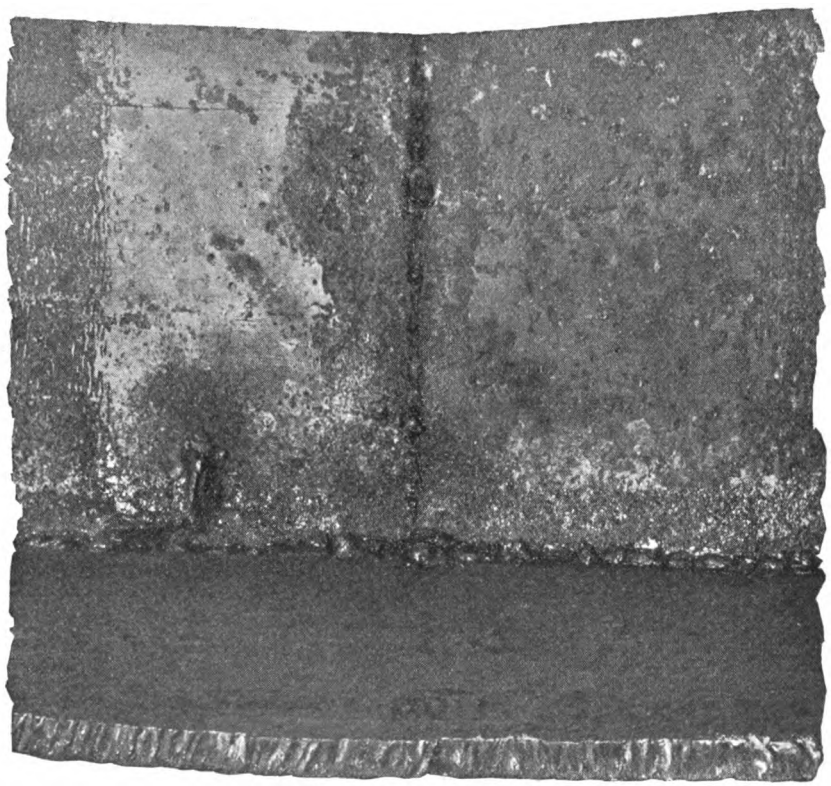
FIG. 3. WELDING OF HEAD TO SHELL. NOTE THE ROUGH CHARACTER OF THE WORK.

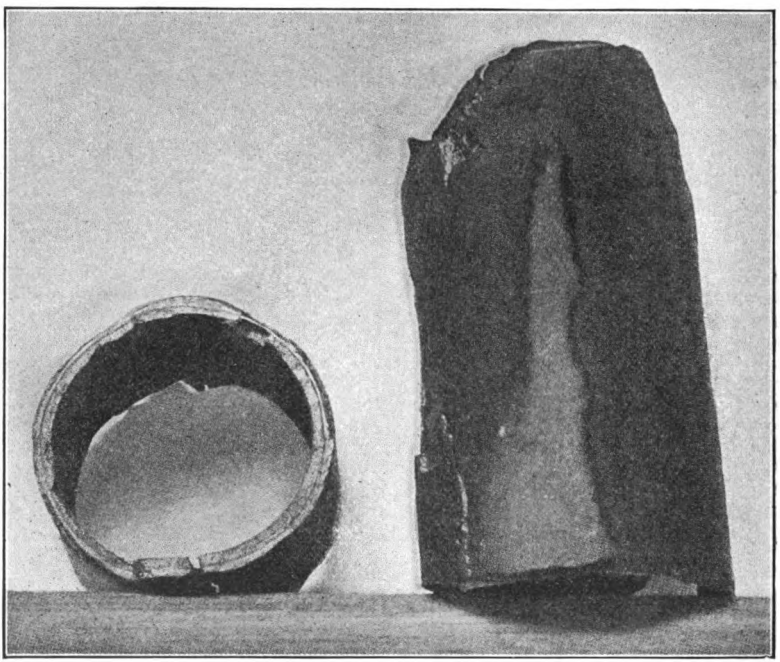
FIG. 1. FIG. 2.

In the case in question, the original thickness of the tubes was .080 in., equal to No. 14 standard gauge (B. W. G.) in a section shown in Fig. 1, the thickness of the remaining metal is .012 in. on one side and on the opposite side the metal has entirely disappeared. The thickness of the oxide is .047 on the outer side and .065 on the inner side. The total maximum thickness of the oxide and the residue of metal is .124 in., which it may be observed is considerably greater than the original thickness of the metal, the difference being due to the expansion of iron and steel in the process of oxidation. Therefore 80 to 100 per cent. of the metal has been converted into oxide, and 15 to 20 per cent. remains in its original condition. Fig. 2 shows the irregularity of the oxidized surface, probably due to the current of steam. Fig. 3 shows the black oxidized surface of the metal after the removal of the principal coating of oxide.

In the present case the boiler was heavily worked, and consequently the temperature in the downtake was high. (This refers of course to a Lancashire or Cornish boiler, where the gases pass *down* to the return flues. Editor.) Also only about one-third of the total amount of steam produced was passed through the superheater. By each of these conditions the temperature of the steam as delivered from the superheater would be increased, and in the combined result the temperature of the steam has been raised beyond the point of safety, as shown by the chemical change produced.

The case is a most instructive one, and imperatively shows that superheaters should not be made so large as to involve any risk of causing excessive temperature in the steam, which obviously is attended with grave danger in direct regard to superheater, pipes and engine; also indirectly in regard to the boiler.
